# BELZONA REPAIR OF FLOATING HOSES

ID: 836

Industry: Oil & Gas  
Application: SOS-Ships and Offshore Structures

Customer Location: Oil Refinery, Philippines  
Application Date: March 2007

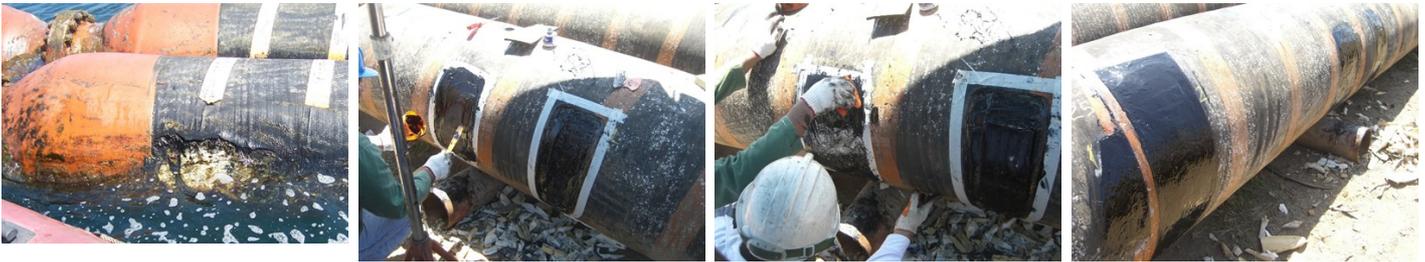
## Photograph Descriptions

Rubber covers and flotation/insulation on fuel hoses was damaged by ships propeller during fuel loading and unloading.

- \* Typical damage ,
- \* New insulation being bonded in with Belzona ,
- \* Final outer cover build-up and coating ,
- \* Completed repair ,

The repair was carried out in accordance with Belzona Know-How System Leaflet SOS-12.
