Welding seams protection

ID: 8360

Industry: *Chemical & Petrochemical*
 Application: *TCC-Tanks and Chemical Containment Areas*
 Substrate: *Carbon steel*
 Products: *Belzona 1341,*

Customer Location: *Petrochemical company, Slovakia*
 Application Date: *October 2021*

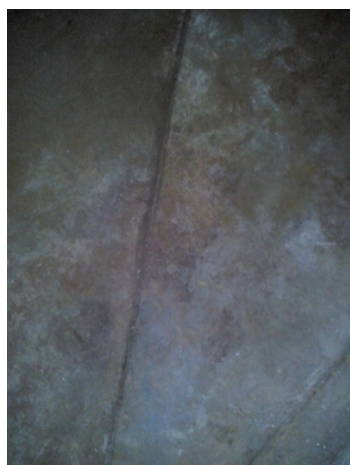
Corrosion on welds. A protective coating was the only option to prevent corrosion.

Corrosion on the welding seams

Tank for gasoline storing shows corrosion on the welding seams.

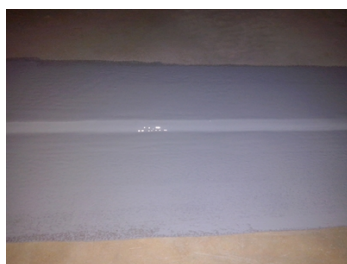
Welding seams was coated by Belzona 1341

Customer needed quick and quality repair. All welding seams were coated by Belzona 1341. Coating was done in 2016. After 4 years no damage was appeared.

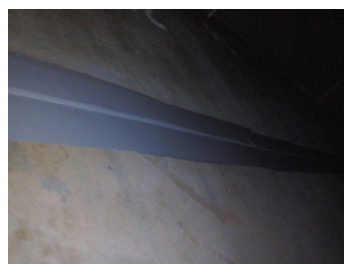
Welding seams was coated by Belzona 1341

After 4 years no damage was appeared.
