Welding seams protection

ID: 8360

Industry: Chemical & Petrochemical
 Application: TCC-Tanks and Chemical Containment Areas
 Substrate: Carbon steel
 Products: Belzona 1341,

Customer Location: Petrochemical company, Slovakia
 Application Date: October 2021

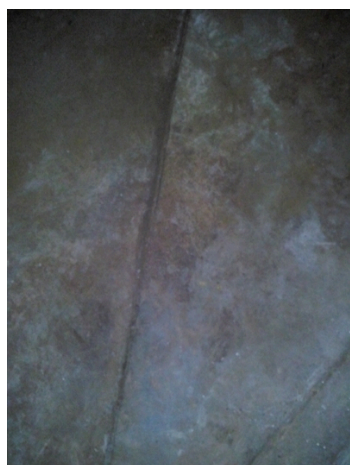
Corrosion on the welding seams

Tank for gasoline storing shows corrosion on the welding seams.

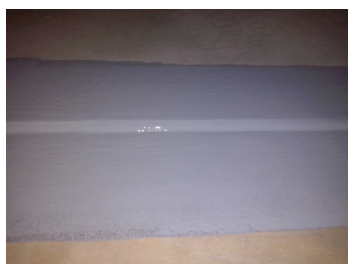
Welding seams was coated by Belzona 1341

Application was carried out in accordance with Belzona Know-How System Leaflet TCC 3

Customer needed quick and quality repair. All welding seams were coated by Belzona 1341. Coating was done in 2016. After 4 years no damage was appeared.

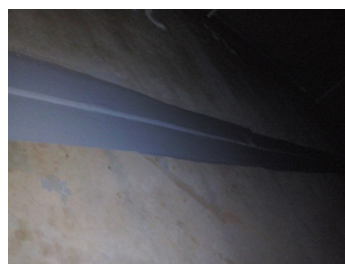
Welding seams was coated by Belzona 1341

After 4 years no damage was appeared.
