Belzona Lays New Chemical Foundation in Food Sector

Application: FPA-Floor Problem Areas

Substrate: Concrete

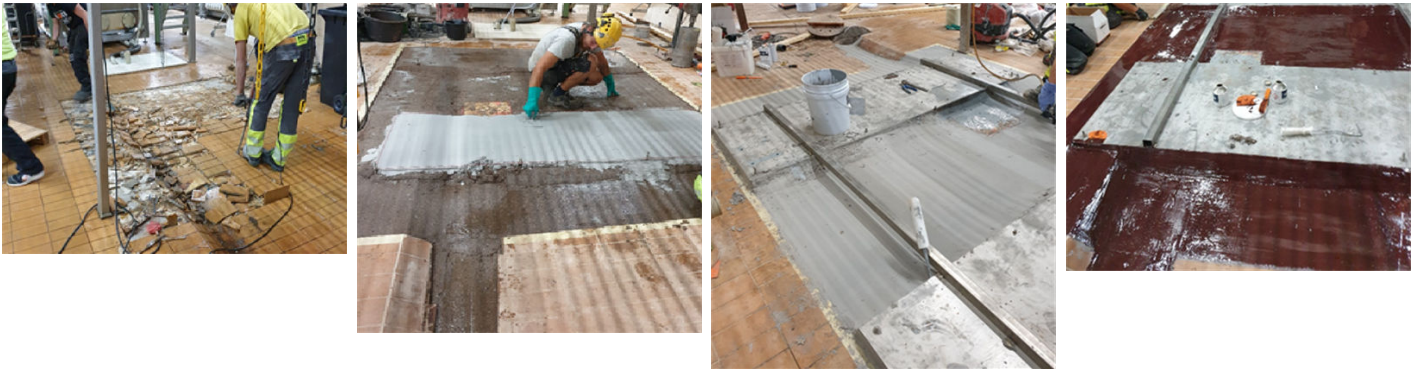
Photograph Descriptions

- * Picture 1 : Old floor de-assembly ,
- * Picture 2 : Deeper areas (2-30cm) filled with Belzona 4154 ,
- * Picture 3 : Belzona 4111 used to reach the final level ,
- * Picture 4 : Belzona 4311 used as a top-coat , a final chemical resistant and safe floor-surface is achieved. ,

A production plant in the Food industry was renewing their process equipment and the old equipment and foundation needed to be disassembled and removed. A new foundation needed to be casted on-site. The final shape and volume of the new foundation could not be determined, until the old chemical deteriorated flooring was removed, cleaned and prepared. Acids used in the production had caused severe deterioration to the existing flooring areas.
