# Belzona Lays New Chemical Foundation in Food Sector

Application: FPA-Floor Problem Areas

Application Date: August 2020

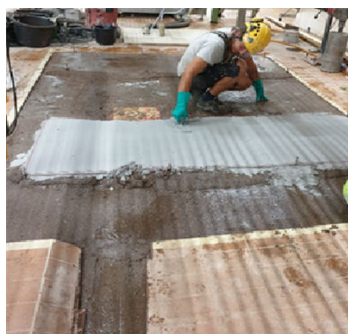
- \* Picture 1 : Old floor de-assembly ,
- \* Picture 2 : Deeper areas (2-30cm) filled with Belzona 4154 ,
- \* Picture 3 : Belzona 4111 used to reach the final level ,
- \* Picture 4 : Belzona 4311 used as a top-coat , a final chemical resistant and safe floor-surface is achieved. ,
