Belzona Repairs Valley Gutters

Industry: Buildings & Structures
Application: RPA-Roof Problem Areas
Substrate: Galvanised steel
Products: * Belzona 3921 (GSC Surface Conditioner) ,
* Belzona 3111 (Flexible Membrane) ,
* Belzona 9311 ,
* Belzona 1212 ,

Customer Location: Huthwaite, UK
Application Date: July 2020

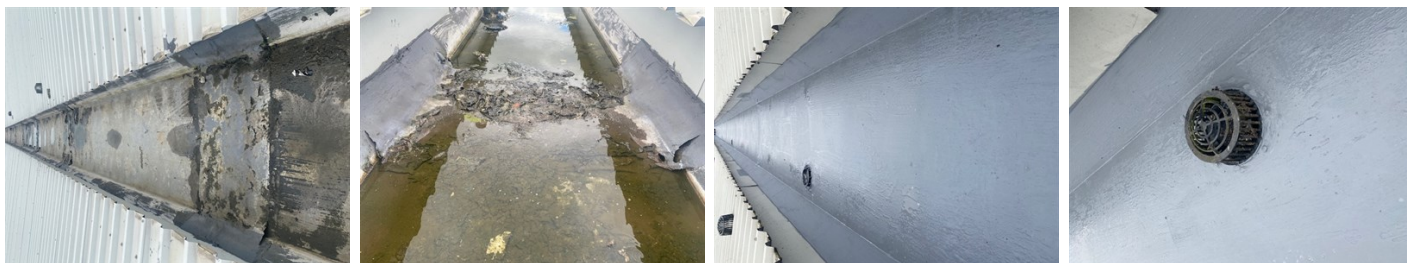
Photograph Descriptions

During periods of heavy rain, sheets of water were falling onto production machinery and stock causing major issues. The client requested that the worst affected areas were prioritised and that all the gutters would be treated to repair the leaks.

- * 1 - General condition of existing valley gutters ,
- * 2 - Condition of existing valley gutter ,
- * 3 - Completed Works ,
- * 4 - Close up of the completed application ,

In accordance with System leaflet RPA-06, the gutters were totally cleaned and obvious holes were repaired Belzona 1212. Belzona 3921 (GSC Surface Conditioner) was applied to all surfaces, followed by application of the full Belzona 3111 system.
