# Heat Exchanger was Recovered and Protected with Belzona

ID: 8369

Customer Location: Geothermal Power Plant, Turkey  
Application Date: July 2020

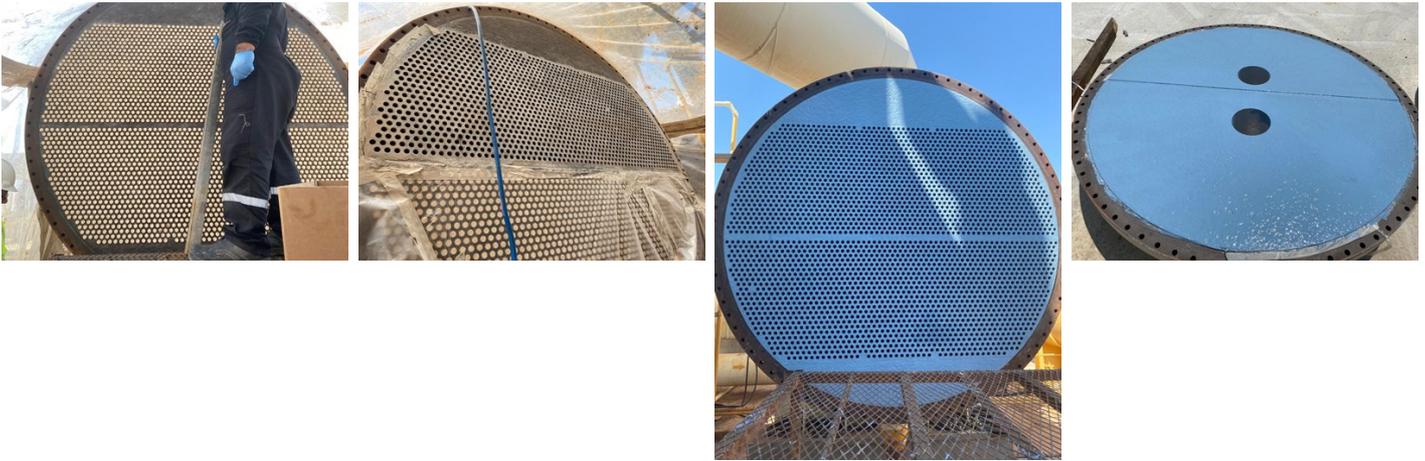
There were leaks due to welding errors and corrosion between the tube sheets and tubes in the Heat Exchangers.

- \* 1- Cork stoppers are installed after grit blasting ,
- \* 2- Belzona 1111 repairing ,
- \* 3- Belzona 1391T protection on tube sheet ,
- \* 4- Belzona 1391T protection on cover ,

Repair and coating process for tube sheets, covers and flanges on 2 faces of a 12 meters long Heat Exchangers in a Geothermal Power Plant. The Belzona coating to be applied had to be resistant to chemical washing.

First of all, the surfaces were grit blasted. Then all the tubing holes were closed with cork stoppers. After repairing was completed with Belzona 1111, the stoppers were removed. After curing, Belzona 1391T coating was applied in 2 layers.

After the application and curing processes were completed, bubble and pressure tests were carried out and there was no problem.
