# Water Pump that the Customer Intends to Replace Comes to Life with Belzona

ID: 8373

Industry: *Fluid Flow*  
Application: *CEP-Centrifugal Pumps*  
Substrate: *Cast iron casing / Bronze impeller*  
Products: *\* Belzona 1311 (Ceramic R-metal) ,*  
*\* Belzona 1321 (Ceramic S-metal) ,*  
*\* Belzona 9111 (Cleaner - degreaser) ,*

Customer Location: *Petrochemical Company, TURKEY*  
Application Date: *August 2020*

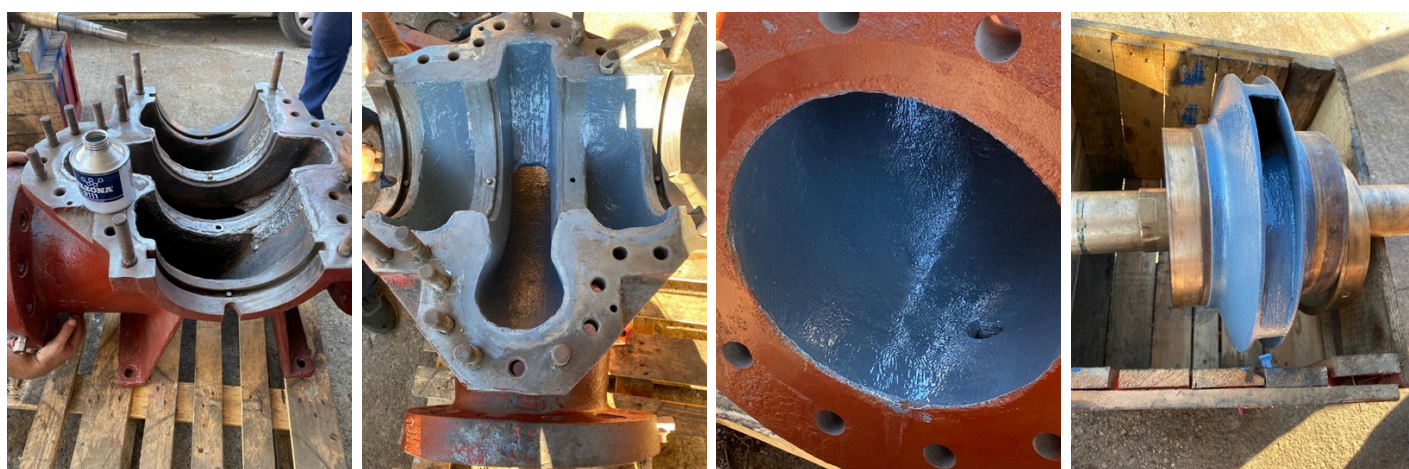
*Abrasion caused by corrosion in the pump body as a result of long operating time*

- \* 1.Belzona 9111 after grit blasting ,
- \* 2.Belzona 1321 coating on Pump Casing ,
- \* 3.Belzona 1321 coating on Pump Casing ,
- \* 4.Belzona 1321 coating on Impeller ,

Application was carried out in accordance with Belzona Know-How System Leaflets CEP-3 & CEP-5

The surface was made ready for application by grit blasting in SA 2.5 Standard. The lost surfaces were recovered by filling repairs with Belzona 1311. Then, Belzona 1321 coating was made and the pump body gained high corrosion resistance.
