Belzona Tank Base Sealing In Service For Over 15 Years

ID: 8385

Customer Location: Refinery, Croatia
 Application Date: 2005

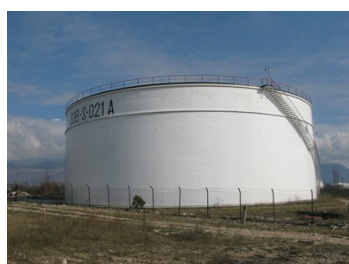
The conventional bituminous method with UV coating failed. Water was penetrating into the tank base. The customer demanded a permanent solution and demanded a 5 year guarantee.

- * 1. Tank before application. ,
- * 2. Application in progress. ,
- * 3. Protected surface 15 years after application. ,
- * 4. Tank after 15 years after application. ,

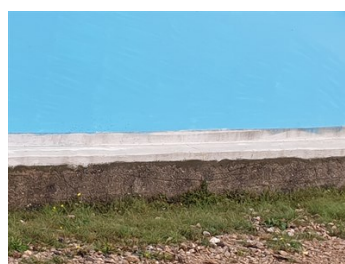
Annual visual inspections were carried out and the system proved to be flawless and permanent. The protection systems ability to

let water out but not to let water in provides longevity in service.
