Belzona Chocking Compound Stabilizes A Lathe

ID: 8393

Customer Location: Malacky, Slovakia
Application Date: 2020

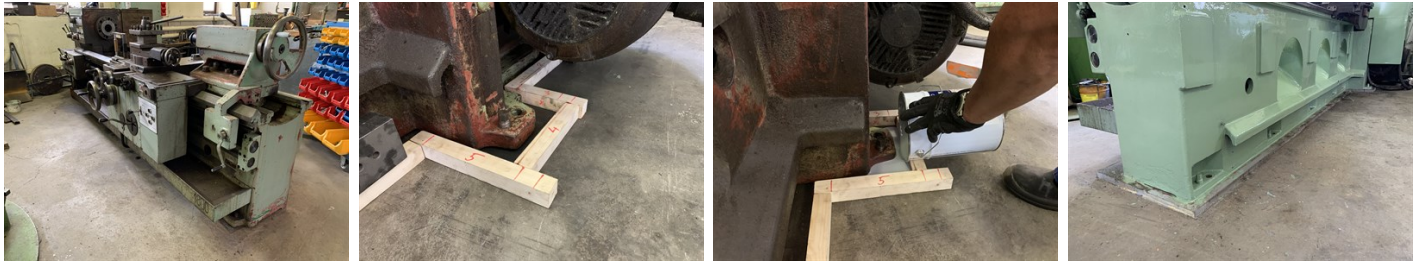
Photograph Descriptions

Lathe required a solution to withstand compressive load of machinery and reduce vibrations.

- * 1. Installed lathe required a solid foundation ,
- * 2. Temporary wood dam prepared ,
- * 3. Pouring Belzona 7111 ,
- * 4. Final Application ,

Installed lathe at a machine building manufacturer which required a solid foundation.

Belzona System Leaflet GSS-13 was used to set up and apply Belzona 7111 to precisely align the equipment.

The Belzona solution secured the equipment for the long-term. Normally the machine would be bolted to the floor, which doesn't prevent corrosion or damage to the baseplate due to vibration.
