Belzona Chocking Compound Stabilizes A Lathe

ID: 8393

Industry: Steel & Metal Processing

Application: GSS-Gaskets, Seals and Shims

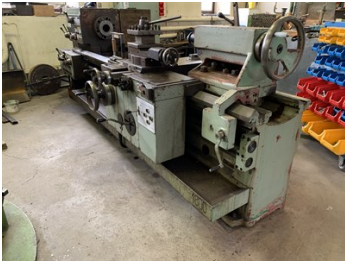
- * 1. Installed lathe required a solid foundation ,
- * 2. Temporary wood dam prepared ,
- * 3. Pouring Belzona 7111 ,
- * 4. Final Application ,

Installed lathe at a machine building manufacturer which required a solid foundation.
