# Belzona Chocking Compound Stabilizes A Lathe

ID: 8393

Customer Location: *Malacky, Slovakia*  
Application Date: *2020*

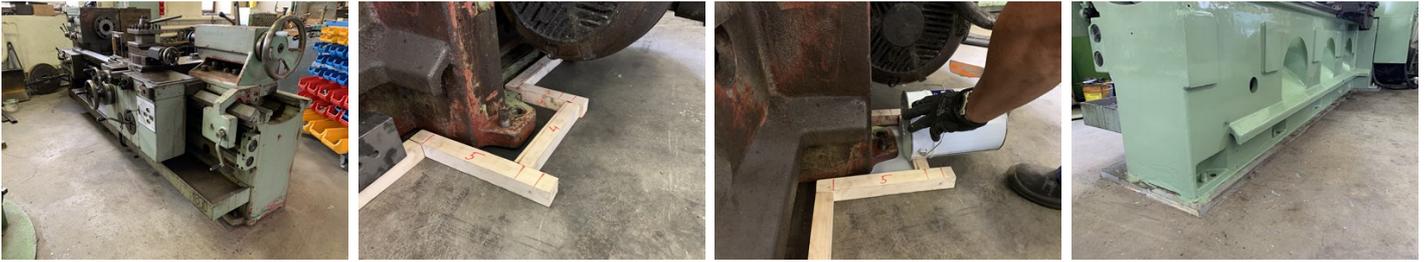
## Photograph Descriptions

- \* 1. Installed lathe required a solid foundation ,
- \* 2. Temporary wood dam prepared ,
- \* 3. Pouring Belzona 7111 ,
- \* 4. Final Application ,

Installed lathe at a machine building manufacturer which required a solid foundation.

Belzona System Leaflet GSS-13 was used to set up and apply Belzona 7111 to precisely align the equipment.

The Belzona solution secured the equipment for the long-term. Normally the machine would be bolted to the floor, which doesn't prevent corrosion or damage to the baseplate due to vibration.
