Belzona 1593 special internal coating

ID: 8395

Industry: Oil & Gas
Application: HEX-Heat Exchangers
Substrate: Steel
Products: * Belzona 1593 ,

Customer Location: Bratislava, Slovakia
Application Date: 2020

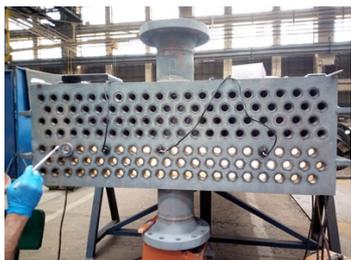
- * 1. Customer needed to protect internal tube sheet ,
- * 2. We needed to use special tools for blasting ,
- * 3. Tube sheet was coated with product Belzona 1593 ,
- * 4. Ready to work ,

Customer needed to protect internal tube sheet of the air condenser. We have offered him product Belzona 1593, which could be used for hydrocarbons in 150°C.
