# Belzona 5721 - Leading edge protection for cold weather blades

ID: 8398

Industry: Power  
Application: FBC-Fans, Blowers and Compressors

Customer Location: Wind Farm, Norway  
Application Date: 2020

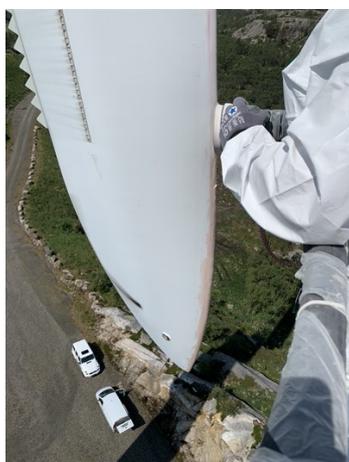
- \* 1. Product Training - Kit ,
- \* 2. Surface Preparation ,
- \* 3. Application in Progress ,
- \* 4. Norwegian Wind farm ,

The application was carried out in accordance with a modified version of Belzona Know-How System Leaflet FBC-1. The blades were coated on the turbine at the operation site. The pitting and loss of surface on the leading edge was resurfaced with a filler product and rebuilt to dimensions. The surface area was sanded down with a mechanical sander and cleaned with a rag and non-residual solvent cleaner. One coat of Belzona 5721 at 20 mils (508µm) was applied.
