# Belzona 7111 used to isolate vibration pads on 3 x Compressors

ID: 8399

Industry: Power  
Application: GSS-Gaskets, Seals and Shims  
Substrate: Concrete  
Products: \* Belzona 71111 ,

Customer Location: Poland  
Application Date: October, 2020

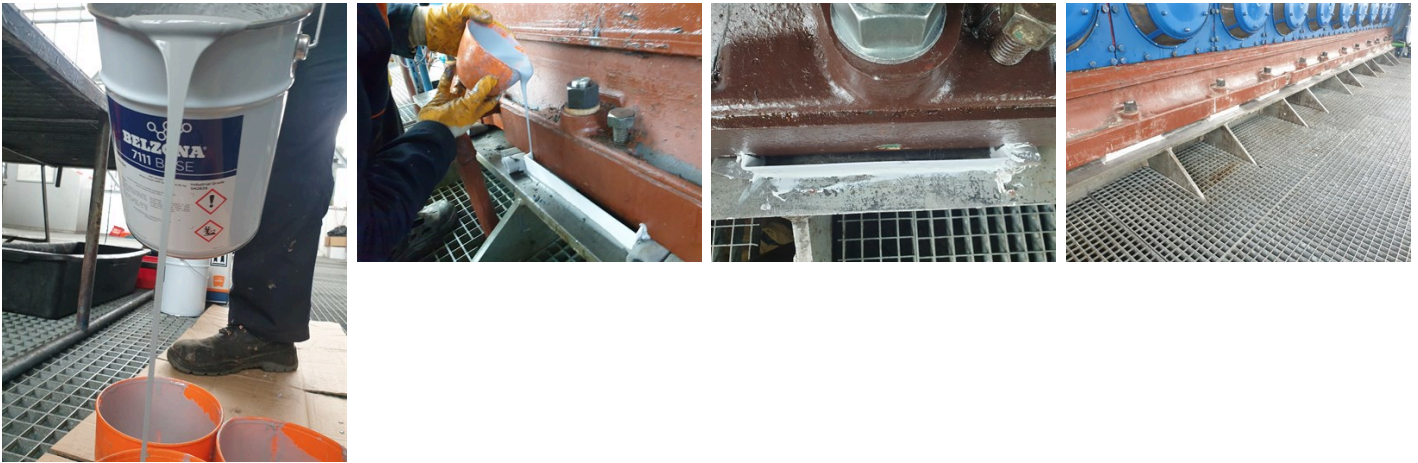
- \* Image 1: Mixing Belzona 7111 ,
- \* Image 2: Pouring Belzona 7111 ,
- \* Image 3: Belzona 7111 close up ,
- \* Image 4: Completed Job ,

In accordance with Belzona system leaflet GSS-12: 1. Unscrew the covers engine. 2. Turning the shaft into check the settings shaft (taking measurements when rotating the shaft, the so-called Springing the shaft) 3. Loosening the screws and screwing in spacer bolts, breaking up the old ones shims 4. Cleaning places of performance (pouring out) new washers 5. Preparation and sealing formwork for pouring Belzona 7111 6 Pouring out of Belzona 7111 7. Removal of formwork and tightening the screws with a force of 1100 Nm
