# Belzona Repairs Damaged Bund Wall

ID: 8400

Industry: General Industry  
Application: TCC-Tanks and Chemical Containment Areas

Customer Location: Staffordshire, UK  
Application Date: August, 2020

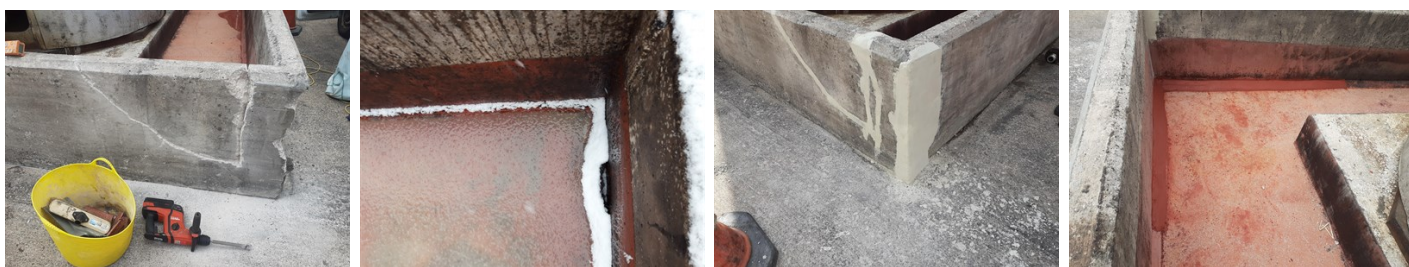
## Photograph Descriptions

While the visible damage is purely cosmetic, if the tank were to spill, the bund would no longer be able to contain the chemicals and they would pass straight to the drains. This would have resulted in an environmental issue and a fine to the site.

- \* 1 - Damage to wall ,
- \* 2 - Damage to fillet ,
- \* 3 - Completed repair to wall ,
- \* 4 - Completed repair to fillet ,

Bund wall and fillet area needed repairing after a collision with a forklift truck caused damage to 2 linear meters of wall to floor joints.

The products were applied in accordance with Belzona System Leaflet TCC-09. The surface was prepared on the external wall of the bund and rebuilt back to its profile using Belzona 4141. After removing approximately 2 linear metres of fillet, Belzona 4181 was used on the internals to restore the damaged concrete..
