# PVC pipe repair

ID: 8403

Customer Location: Malacky, Slovakia  
Application Date: 2020

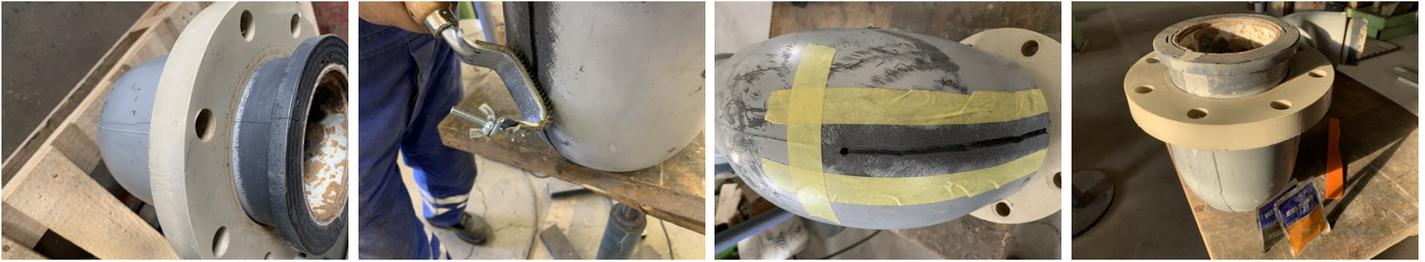
## Photograph Descriptions

- \* 1. Customer needed to repair the crack ,
- \* 2. We roughened surround place using the Belzona roughing brush. ,
- \* 3. Ready for Belzona 1221 application ,
- \* 4. Repaired pipe bend ,

Customer destroyed a PVC pipe bend (diameter 160 mm, wall thickness 10 mm, with hydrostatic pressure, temperature up to 20°C) during some cooling tower dismounting and maintenance.

The application was performed in accordance with modified Belzona system leaflet VPF-8. Firstly we made the test with Belzona 1221 application on the small area of this bend. Adhesion was perfect. Then we started to repair the entire crack. We terminated the crack by drilling 6 mm hole at the end to prevent further propagation, "veed" out crack with a hand held machine, then roughened it using the Belzona roughing brush. After chemical cleaning was Belzona 1221 applied.
