# Bolster Side Bearer Mounting Face Repair with Belzona 1111

ID: 8404

**Industry:** Transport  
**Application:** TCC-Tanks and Chemical Containment Areas  
**Substrate:** Steel  
**Products:** \* Belzona 9111 (Cleaner Degreaser),  
\* Belzona 9411 (Release Agent),  
\* Belzona 1111 (Super Metal),

**Customer Location:** South Yorkshire, UK  
**Application Date:** August 2020

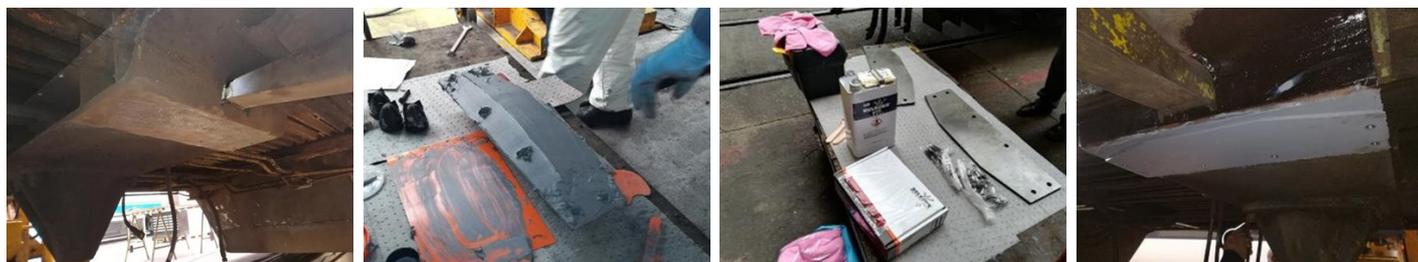
## Photograph Descriptions

The greatest area of concern is the vehicle bolster structure as this exhibits the most damage and acts as the interface between the side bearers and the vehicle. Exfoliation corrosion has occurred between the body shims and the side bearer top plate mounting on the vehicle bolster structure. This has led to a particularly deep uneven surface caused by the wasting of the original plate thickness on the vehicle bolster. Given this area supports the side bearer, any flexing allowed in the side bearer assembly may have a detrimental effect to the ride quality of the vehicle and the wheel loading's.

\* Photo 1: The damage on the bolster. Photo 2: The application plates that will be attached to surface using belzona 1111. Photo 3: Belzona 1111 on the application plate in a pyramid form. Photo 4: Finished application. ,

1. Brushed away loose contamination and degreased using Belzona 9111. 2.All surfaces were prepped using Grit Blasting to give a surface finish of Swedish Standard Sa2½, ensuring a minimum surface profile of 3 mils (75 Microns).
3. Two coats of Belzona 9411 were applied to any areas of the vehicle bolster immediately surrounding the intended repair area for a distance of 25mm (1") to which the Belzona was not required to adhere.
- 4.Base and Solidifier of 1111 were mixed together thoroughly, until combined with no streaks.
5. Belzona 1111 was applied directly onto the prepared Bolster Side Bearer mounting face surface with a short bristle brush.
6. An excessive quantity of Belzona 1111 was applied to the top surface of the Belzona Application plate face in the shape of

an elongated pyramid, with the highest section running longitudinally along the centre of the Belzona Application plate. 7. The Application plate was then pushed onto the guide pin of the bolster surface sufficiently to enable the guide pin nuts to be wound up the guide pins. 8. Once cured the application plate was removed.
