40+ YEAR OLD CONDENSERS RESTORED WITH BELZONA

Industry: Power
Application: HEX-Heat Exchangers
Substrate: Muntz metal
Products: * Belzona® 1321 (Ceramic S-Metal) ,
* Belzona® 1311 (Ceramic R-Metal) ,

Customer Location: Power Plant, Illinois
Application Date: May 2007

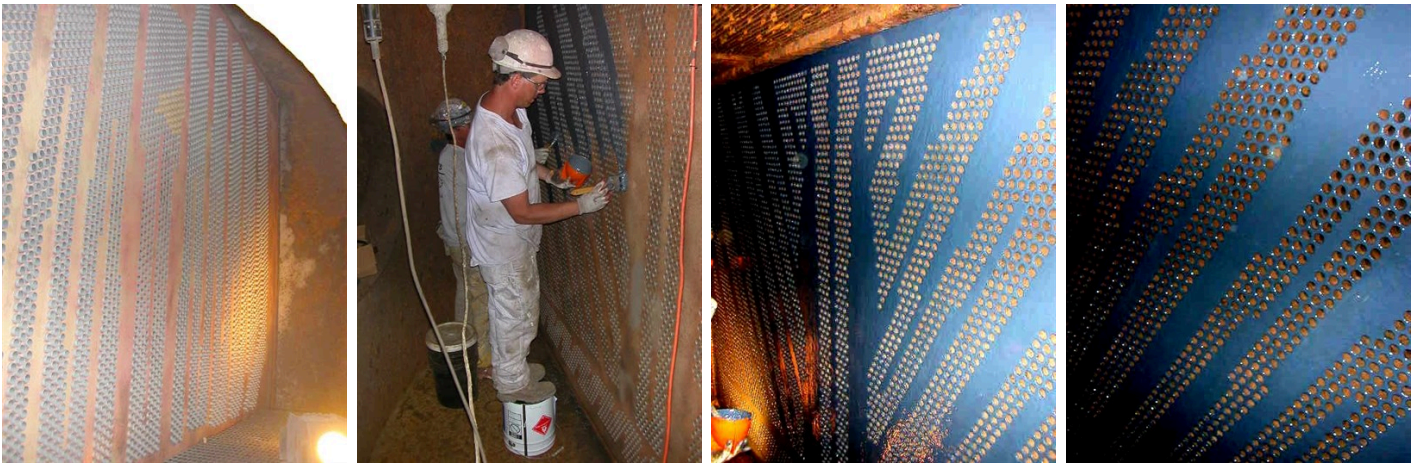
Photograph Descriptions

The leaks caused a rise in the condensate return water silicon content from 200 ppm to 4,600 ppm which in turn contaminates the boiler and contributes to corrosion.

- * Blast cleaned tube sheet ,
- * Coating underway ,
- * Completing the application ,
- * Finished application ,

Leaks between the stainless steel tubes and Muntz metal tube sheets on eight tube sheets

Application carried out in accordance with Belzona System Leaflet HEX-1 & HEX-3.
