Belzona 1813 Protects a Fan Wheel at a Gravel Plant

ID: 8410

Industry: Mining & Quarrying
Application: SHM-Solids Handling Machinery

Customer Location: Switzerland
Application Date: November, 2020

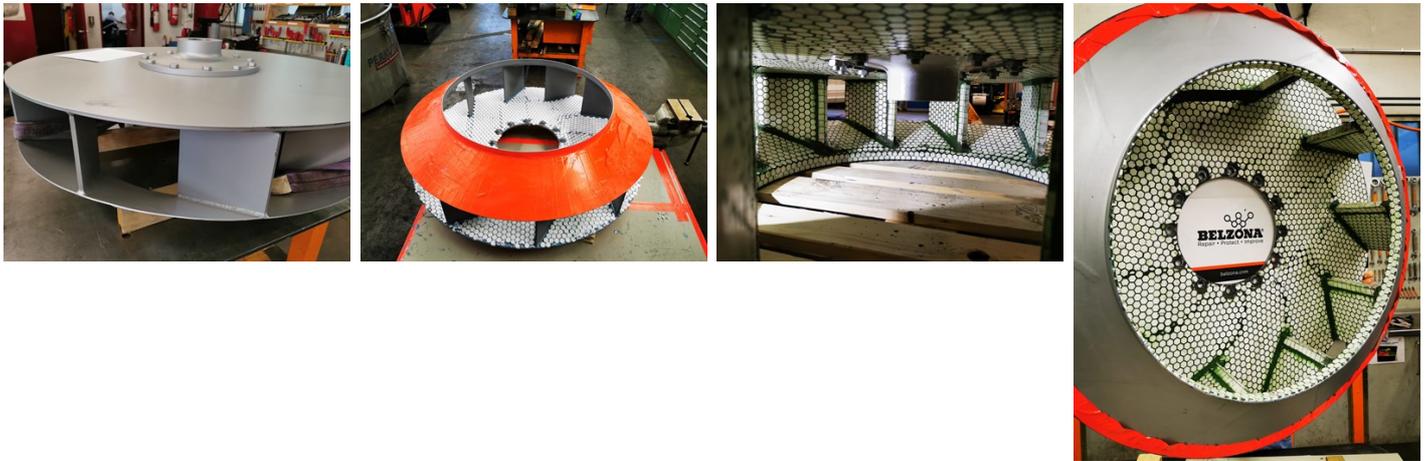
Photograph Descriptions

Problem

The customer experienced strong abrasion issues on the inside and outside of the blades. The impeller rotates at approx. 2500 revolutions. In addition, temperatures of 150 to max 200 ° C prevail.

* Image 1: Fan Impeller Grit Blasted Image 2: Belzona 9811 Applied onto Belzona 1391T Image 3: Belzona 1813 applied to the Belzona 9811 Image 4: Complete Application ,

The customer at the gravel plant has been struggling with abrasion issues due to fine dust from earth, stone and mud on the fan wheel.

The fan impeller was grit blasted in accordance with the standard Belzona surface preparation. They then applied Belzona 1391T and attached the Belzona 9811 Alumina tiles to offer extra abrasion resistance and grouted with Belzona 1813 in accordance with a modified version of Belzona system leaflet SHM-7.

The client tried to weld with various material (hard metal) unfortunately it was unsuccessful. They then turned to Belzona to offer a

solution for abrasive environments.
