# Belzona helps give a ship caisson a makeover

Industry: Marine  
Application: SOS-Ships and Offshore Structures

Customer Location: Brest, France  
Application Date: 2020

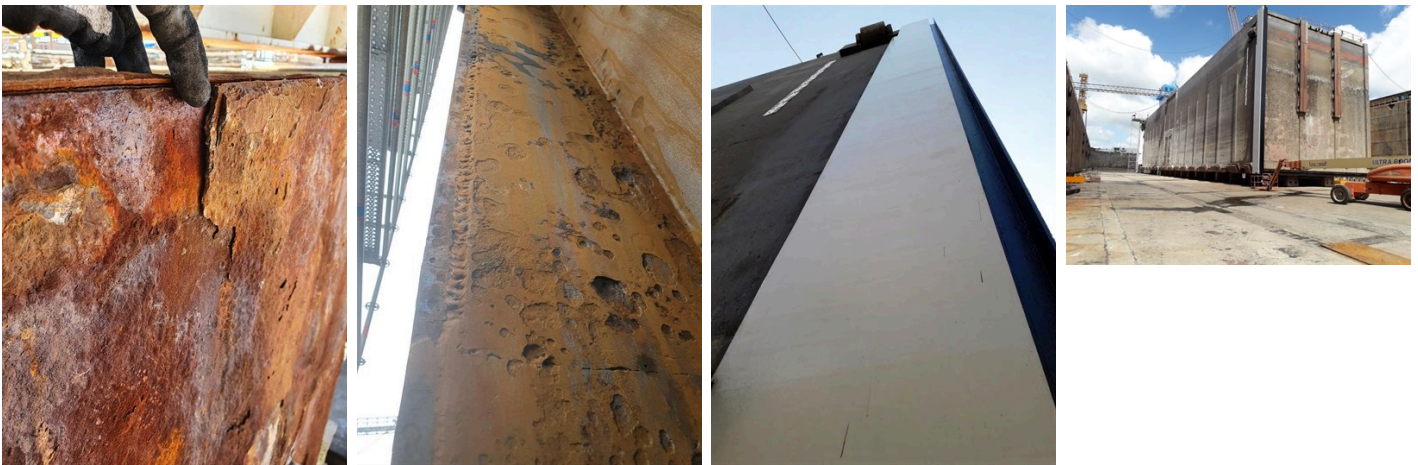
## Photograph Descriptions

The ship caisson was experiencing severe corrosion which deteriorated the surfaces in contact with the mobile gates. This deterioration led to the material loss of the lateral plates substrate to which the gates press against and form the seal. This meant that the creation of a watertight seal by the caisson and the gates could not be ensured, and therefore making the caisson not fit for its operational purpose. The main issues that the ship caisson was experiencing were:

Several losses of thickness all over the surface with some more specifically deteriorated areas.

Severe wear on the central part which adheres to the gates on a surface of 45 cm (caused by a combination of marine corrosion and joint friction) which led to 20 mm of lost thickness.

- \* 1. Severe deterioration of substrate ,
- \* 2. Ready for Surface Preparation ,
- \* 3. Resurfaced and protected substrate ,
- \* 4. Ship caisson repaired and ready to operate again ,

The dimensions of the bearing facades of the caisson ship which needed to be resurfaced and protected were 18 metres x 1.1 metres. After cleaning and preparing the surface through grit blasting, a protective coat of Belzona 1331 was applied to due to its outstanding erosion and corrosion resistance under immersion.

Belzona 5811 which protects equipment operating under immersion from corrosion, was first applied on the prepared surface to protect it from oxidation prior to being reprofiled. Belzona 1111, an epoxy-based composite was then applied to rebuild the corroded surfaces of the plates. In order to achieve a tolerance of  $1 < \text{mm/m}$ , An industrial plumb line and a bolt welded on the substrate was used to achieve the ideal thickness.
