## Belzona Keeps Fishing for 20 years.

ID: 8427

Industry: *Marine*  
 Application: *FPA-Floor Problem Areas*  
 Substrate: *Steel*  
 Products: *\* Belzona 4911 (Magma TX conditioner),*  
*\* Belzona 4111 (Magma Quartz),*

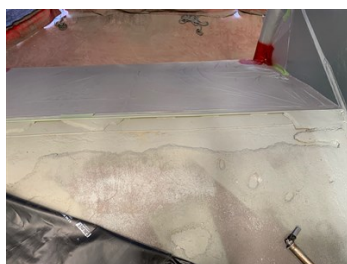
- \* 1. Fishing Trawlers ,
- \* 2. Stern ramp deck prior to repair ,
- \* 3. Close up of original 20 year old Belzona 4000 product ,
- \* 4. New repairs complete. ,

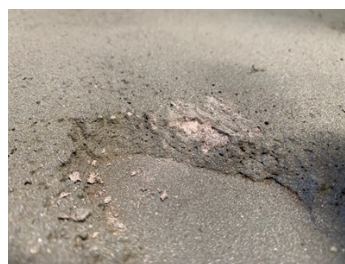
*Now in 2020, some 20 years after the original application, some localized areas required attention and re-laying of Belzona 4111.*

The localized areas were mechanically abraded and the Belzona 4111 was troweled into the areas to be patched.

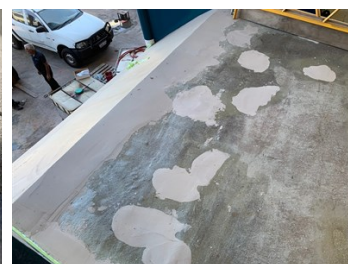
The same engineer applied both Belzona products some 20 years apart - it was very evident that the original Belzona was extremely durable and robust making the decision to carry out the patch repairs with Belzona a very easy one.
