# Belzona Keeps Fishing for 20 years.

Industry: *Marine*  
 Application: *FPA-Floor Problem Areas*  
 Substrate: *Steel*  
 Products: *\* Belzona 4911 (Magma TX conditioner),*  
*\* Belzona 4111 (Magma Quartz),*

Customer Location: *Perth, Western Australia*Application Date: *2000 and 2020*

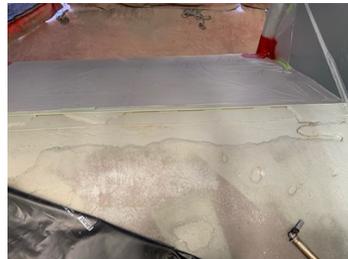
Now in 2020, some 20 years after the original application, some localized areas required attention and re-laying of Belzona 4111.

- \* 1. Fishing Trawlers ,
- \* 2. Stern ramp deck prior to repair ,
- \* 3. Close up of original 20 year old Belzona 4000 product ,
- \* 4. New repairs complete. ,

The localized areas were mechanically abraded and the Belzona 4111 was troweled into the areas to be patched.
