# BELZONA REPAIRS TO ROOFTOP EXHAUST DUCTING

ID: 843

Rooftop exhaust ductwork

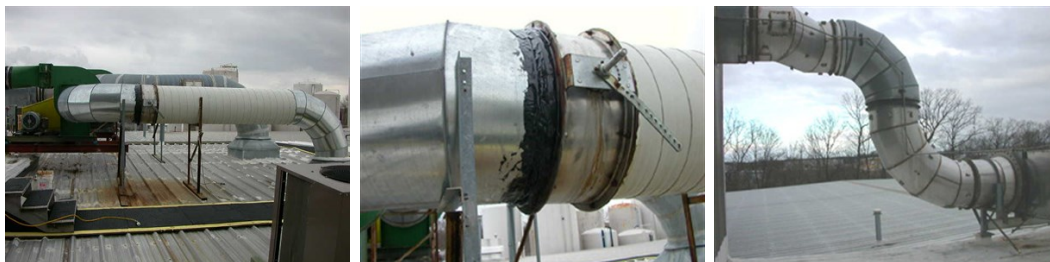
Joints were leaking allowing escape of unpleasant gases into the neighbourhood leading to many complaints.

\* First duct joint , \* Close up of first joint repair , \* Second joint repair ,

Application carried out using a modified Belzona System VPF-11a
