# Belzona Solutions for Heat Exchangers

**Industry:** Heating, Ventilation & Air Conditioning  
**Application:** HEX-Heat Exchangers  
**Substrate:** Carbon steel  
**Products:** Belzona 1311 (Ceramic R-Metal),  
Belzona 1321 (Ceramic S-Metal),

**Customer Location:** Burbank, CA  
**Application Date:** December 2020

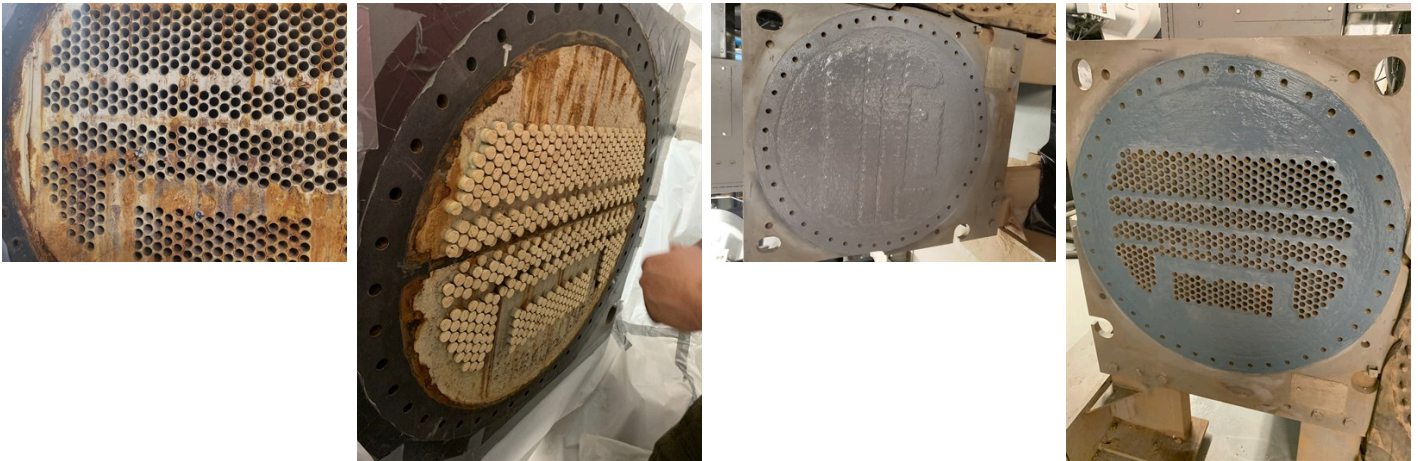
*if the corrosion allowance is exceeded and gaps appear, recirculation can occur, leading to efficiency loss. In addition, the processed fluid can erode the metal further, accelerating degradation if corrosion is already present.*

Shell and tube heat exchangers, also referred to as chillers, are a vital part of any heating or air conditioning system. Failure to quickly protect these units allows galvanic corrosion to take place, resulting in wastage and metal loss on the tube sheet around the coolant tubes. Left untreated, the loss of metal can cause leakage of the coolant and contamination of the chilled water. Corrosion is not restricted to the tube sheet, the water box and end covers can also be affected. In particular, corrosion in division bars and seal faces can lead to leakage and loss of efficiency, as well as the inability to maintain the desired working environment in buildings.

The affected section is rebuilt using Belzona's two-component repair composites. The paste grade material Belzona 1311 (Ceramic R-Metal) rebuilds the substrate to its original tolerances, while the fluid grade system Belzona 1321 (Ceramic S-Metal) provides a layer of durable protection. This cold-applied repair process bypasses the need of hot work that would leave the substrate susceptible to further damage. Belzona polymeric technology isolates the dissimilar metals, preventing further galvanic corrosion. The tough repair and coating system also protects the chiller against the effects of erosion and, as a result, increases asset life and efficiency while avoiding replacement. Belzona materials are easy and quick to apply by hand, reducing downtime and hazards during application.

The Belzona solution not only restores the original tube sheet profile, but also creates a smooth tube sheet face flush with the tube

ends, leading to reduced turbulence and greater efficiency. Water boxes and end covers can also be repaired and protected.
