# Belzona Protects Screw Conveyor Against Abrasive Attack

ID: 8433

Customer Location: Biomass Plant, Glasgow, UK  
Application Date: November 2019

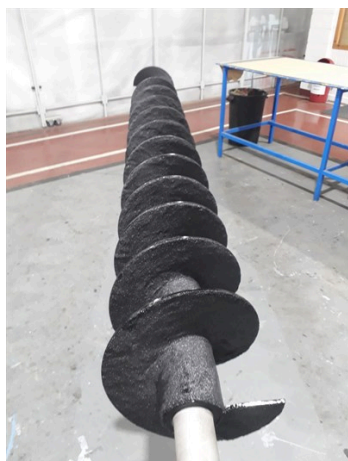
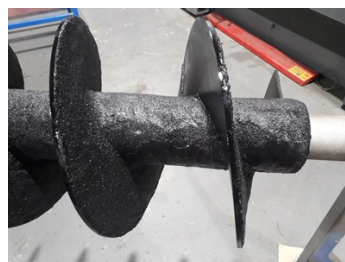
High abrasion was leading to unprotected screws only lasting 3-4 months in service. Previous Belzona applications on this type of screw was completed with Belzona 1812, which extended their life to over 2 years.

Screw conveyor used to skim sludge from the base of a silo at a biomass plant.

The application was completed in accordance with system leaflet SHM-14. The screw conveyor was grit blasted to SA2 1/2 with a minimum surface profile of 3 mil (75 microns). The area to be coated was then cleaned and degreased using Belzona 9111. Belzona 1814 was applied by brush to the entire area of the conveyor to provide long-term protection against heavy abrasion.
