Axial Flow Pump Coating with Belzona

ID: 8435

Customer Location: Water Authority, Scotland, UK

Application: CEP-Centrifugal Pumps

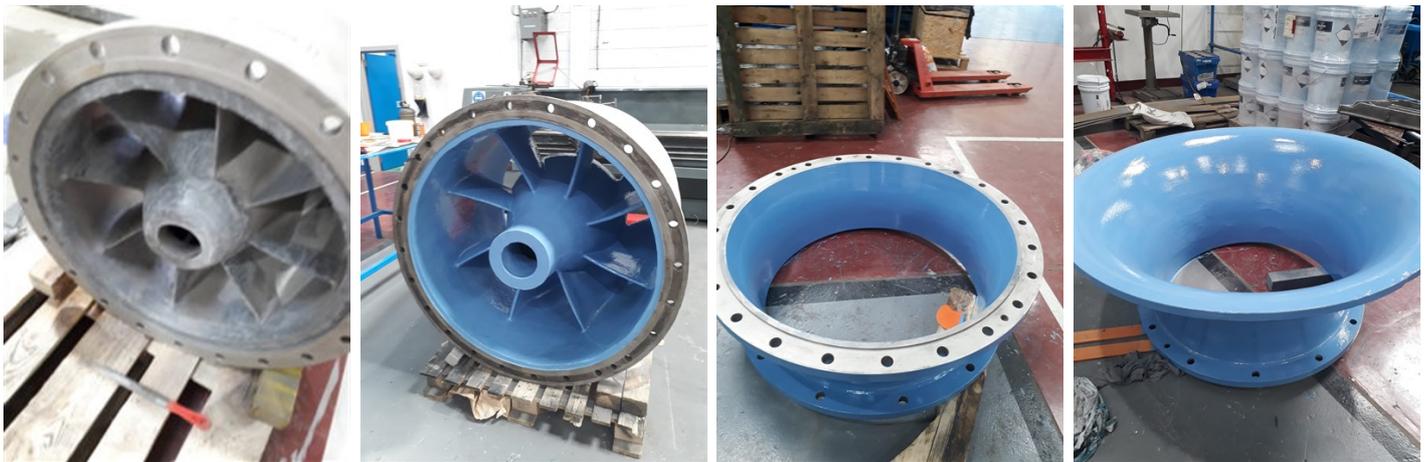
Photograph Descriptions

The diffuser vanes of the pump has suffered extensive damage from erosion. Due to the age of the pump spare parts were not available & a replacement diffuser would need to be fabricated from new (the cost would be approx. £40,000).

* Suction Bell Suction bell coated with Belzona 1341 Part coated with Belzona 1341 Part coated with Belzona 1341 ,

An axial flow pump was suffering from erosion & corrosion in service. The metal loss was affecting the flow characteristics & efficiency of the pump. A solution that protected the equipment from further damage & increased the pumping efficiency was required.

The parts were grit blasted to SA2.5 & 75 microns. The diffuser vanes & other damaged parts were rebuilt using Belzona 1311 as per CEP-01. The area was then coated with Belzona 1341 as per CEP-03.

By utilising a Belzona solution the existing parts were not only repaired but also improved from an erosion resistance & efficiency stand point. The full axial flow pump repairs were completed for less than half the cost of purchasing a new diffuser (only one part of the full pump).
