# Belzona used for the protection of a wind turbine blade

ID: 8441

Customer Location: Galicia, Spain  
Application Date: March 2020

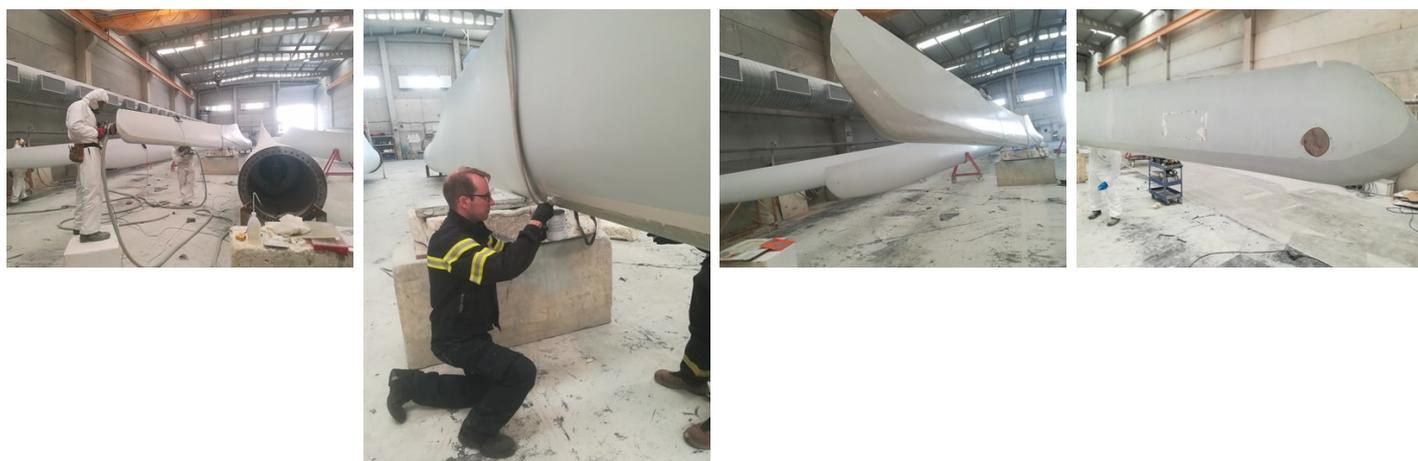
Erosion of the leading edge of the blades caused by impact from rain droplets. Routine inspection and periodic repair is required to keep the turbine running efficiently.

- \* 1. Surface preparation ,
- \* 2. Application of Belzona 5721 ,
- \* 3. First layer complete ,
- \* 4. Final layer complete ,

The leading edge of the blade has been prepared using hand held sander power tool, removing the existing gel-coat and to provide a clean and rough surface. After cleaning the prepared area, the Belzona 5721 system has been applied as a one-coat system at an average of 500 microns.
