Belzona used for the protection of a wind turbine blade

ID: 8441

Customer Location: Galicia, Spain
Application Date: March 2020

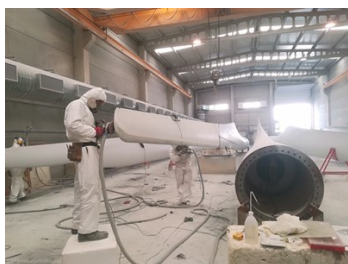
- * 1. Surface preparation ,
- * 2. Application of Belzona 5721 ,
- * 3. First layer complete ,
- * 4. Final layer complete ,

The leading edge of the blade has been prepared using hand held sander power tool, removing the existing gel-coat and to provide a clean and rough surface. After cleaning the prepared area, the Belzona 5721 system has been applied as a one-coat system at an average of 500 microns.
