# Belzona Provides Cold Bonding Solution to Storage Tank

Customer Location: Dublin, Ireland

Substrate: Glass Fused Steel

Products: \* Belzona 1111 (Super Metal) ,  
\* Belzona 5811 (Immersion Grade) ,

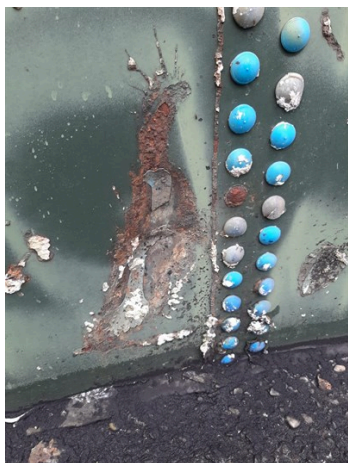
A crisp factory located in Dublin, Ireland, had suffered from corrosion within a storage tank containing process wastewater. Over time, the glass fused steel resulted in multiple through-wall defect areas on the substrate surface, which if left untreated, could have produced a serious problem with environmental and economic impacts. The Customer was in need of a quick, yet simple solution that ultimately ruled out the need for replacement and one that would have minimal impact on production.

- \* 1. Damage to the surface ,
- \* 2. Surface preparation and plate bond using Belzona 1111 ,
- \* 3. First coat of Belzona 5811 ,
- \* 4. Second coat of Belzona 5811 ,
