# Belzona takes the heat off

ID: 8453

Industry: Steel & Metal Processing  
Application: VPF-Valves, Pipes and Fittings  
Substrate: Carbon Steel  
Products: \* Belzona 5871 ,

Customer Location: Huelva, Spain  
Application Date: November 2020

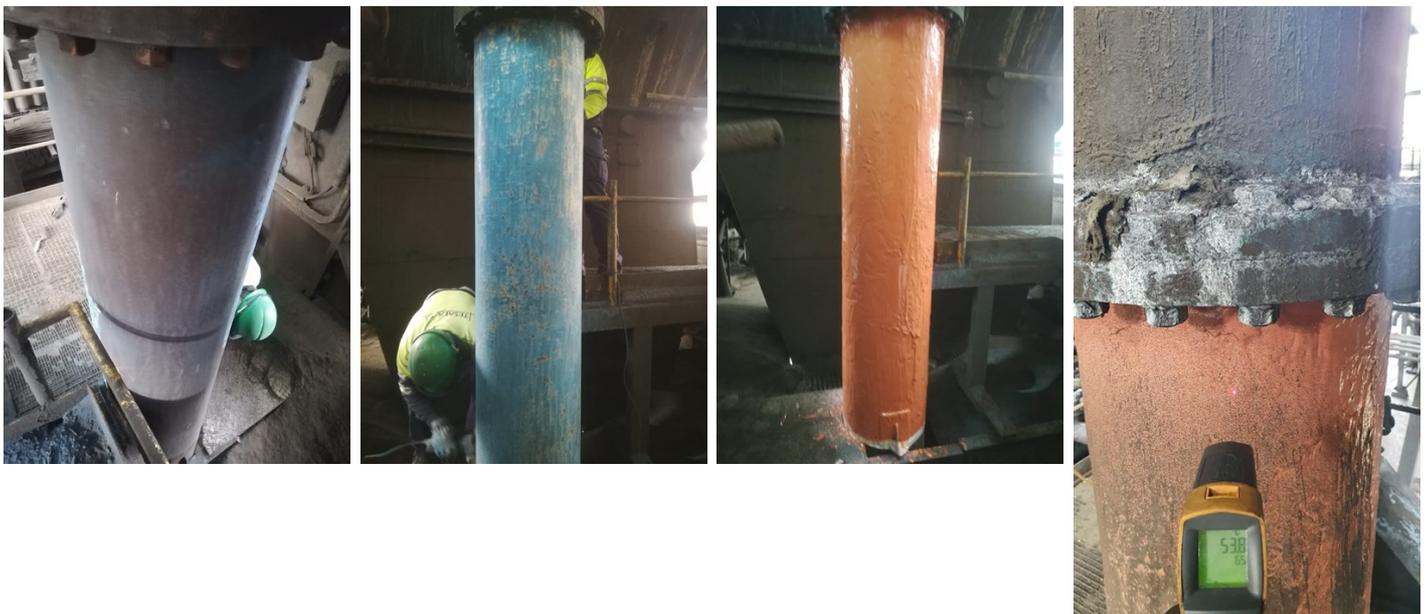
Due to the contamination and dirt found in the environment close to the pipeline, the insulation material had degraded and was no longer fit for purpose. Unfortunately, this left the hot surface of the pipeline exposed, causing a hazard to personnel working in the area. The pipeline operated at between 80C and 100C. The surface must be below 60C to be considered safe.

- \* 1. Pipe prior to application ,
- \* 2. Surface preparation completed ,
- \* 3. Application completed ,
- \* 4. Surface temperature after curing ,

Manual preparation tools were used to remove contamination, such as corroded material, from the substrate, and to create a rough surface to aid the adhesion of the Belzona 5871. Belzona 5871 was then applied at a 1.5mm wet film thickness to achieve a dry film

thickness of 4.5mm.

The key factor in this situation was to minimise the downtime of the equipment. Due to the single layer application of the Belzona 5871, the application was carried out, and sufficient curing time achieved, within a 6 hour downtime window. Alternative solutions included reinstatement of traditional insulation, which would have taken much longer to install, therefore increasing the downtime. The final surface temperature after the Belzona 5871 was fully cured was below the 60C limit, making it safe for personnel to work in the area.
