Belzona repairs and protects separator outlet in paper mill

Application: *SHM-Solids Handling Machinery*

Application Date: *January 2021*

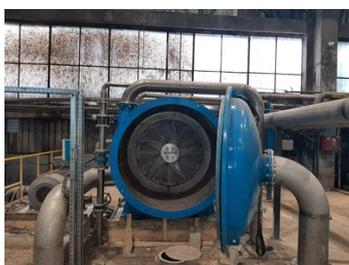
- * 1. View of the Separator ,
- * 2. Cracked outlet pipe ,
- * 3. Crack repaired with Belzona 1111 ,
- * 4. Application completed with Belzona 1811 ,

Basalt lined outlet area of a separator in a paper mill.

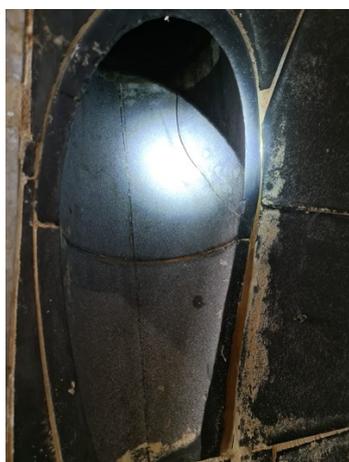
The Basalt lining was worn due to the erosive operating conditions of the separator. In the outlet pipe, a crack had formed due to the high impact loading in this area.

The cracked area has warped, leaving one side of the crack raised above the other, which in turn accelerated the abrasive wear. Traditional solutions such as welding would only fill the gap and not allow for a smooth finish to help reduce the abrasive wear. Belzona was able to reinforce the cracked area and smooth the internal section of the pipe. Belzona 1811 was chosen due to its high abrasion resistant properties and ease of application in situ. The application was completed within 2 days, keeping down time to a minimum.
