# Belzona repairs and protects separator outlet in paper mill

ID: 8466

Industry: *Pulp & Paper*

Application: *SHM-Solids Handling Machinery*

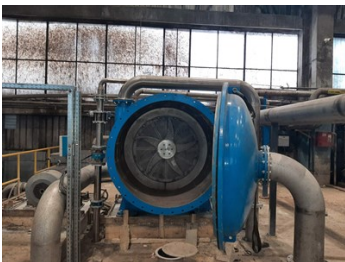
- \* 1. View of the Separator ,
- \* 2. Cracked outlet pipe ,
- \* 3. Crack repaired with Belzona 1111 ,
- \* 4. Application completed with Belzona 1811 ,

Basalt lined outlet area of a separator in a paper mill.

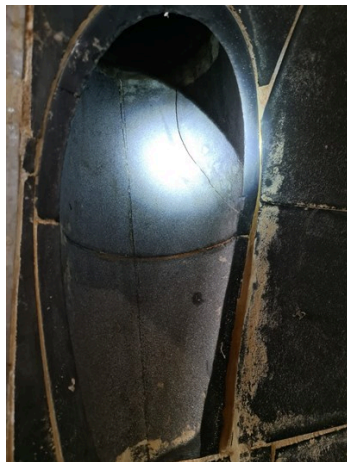
*The Basalt lining was worn due to the erosive operating conditions of the separator. In the outlet pipe, a crack had formed due to the high impact loading in this area.*

The cracked area has warped, leaving one side of the crack raised above the other, which in turn accelerated the abrasive wear. Traditional solutions such as welding would only fill the gap and not allow for a smooth finish to help reduce the abrasive wear. Belzona was able to reinforce the cracked area and smooth the internal section of the pipe. Belzona 1811 was chosen due to it's high abrasion resistant properties and ease of application in situ. The application was completed within 2 days, keeping down time to a minimum.
