Wastewater repair and protection with Belzona

Application: VPF-Valves, Pipes and Fittings

Sewage water pipelines at a waste water treatment facility.

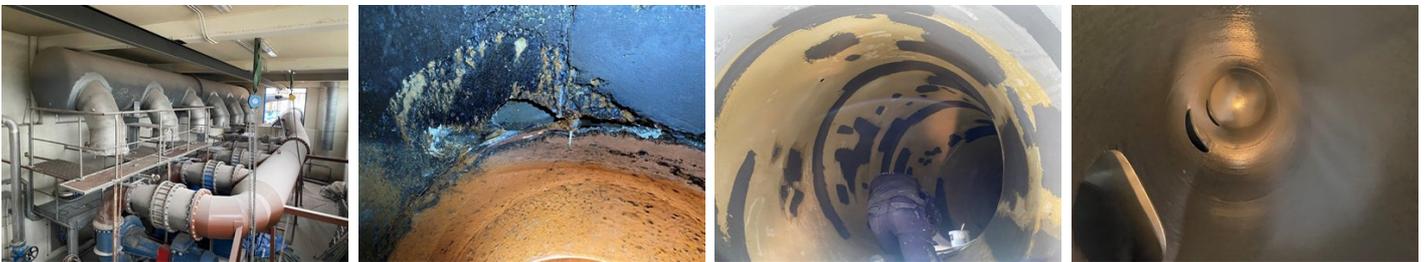
Photograph Descriptions

Internal corrosion of the pipelines has led to severe degradation of the substrate including heavy pitting. In some areas, the loss of wall thickness is reaching a stage where the structural integrity of the pipeline would be compromised. Action is needed to repair the existing damage and prevent further corrosion.

- * 1 - Outside of the pipes to be repaired ,
- * 2 - Corroded condition inside the pipe ,
- * 3 - Surface prepared and rebuilding in progress ,
- * 4 - Coating completed ,

The application was carried out using a modified version of Belzona System Leaflets VPF-01 and VPF-02. After surface preparation by grit blasting to remove corroded material, free to surface of contaminants, and provide a surface profile, the pitted areas were repaired with Belzona 1111 and Belzona 4111. Finally, a 2 coat system of Belzona 5811 was used to protect from further corrosion.
