# BELZONA PROTECTION OF INTERNAL & EXTERNAL SURFACES OF LIFT PUMP

Industry: Oil & Gas  
Application: CEP-Centrifugal Pumps  
Substrate: Aluminum Bronze  
Products: \* Belzona® 1341N (Supermetalgilde) ,  
\* Belzona® 1111 (Super Metal) ,

Customer Location: Oil Company, Saudi Arabia  
Application Date: April 2007

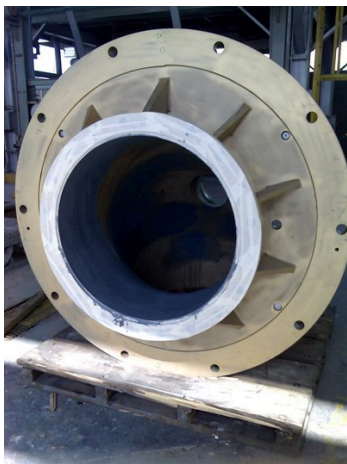
- \* Rebuilding the pump head ,
- \* Spools after blasting ,
- \* External coating for spools ,
- \* Completed application ,

The application was carried out in accordance with Belzona Know-How System Leaflets CEP-3 and CEP-5.
