BELZONA SCRUBBER FAN COATING

ID: 8476

Industry: *Mining & Quarrying*
Application: *FBC-Fans, Blowers and Compressors*

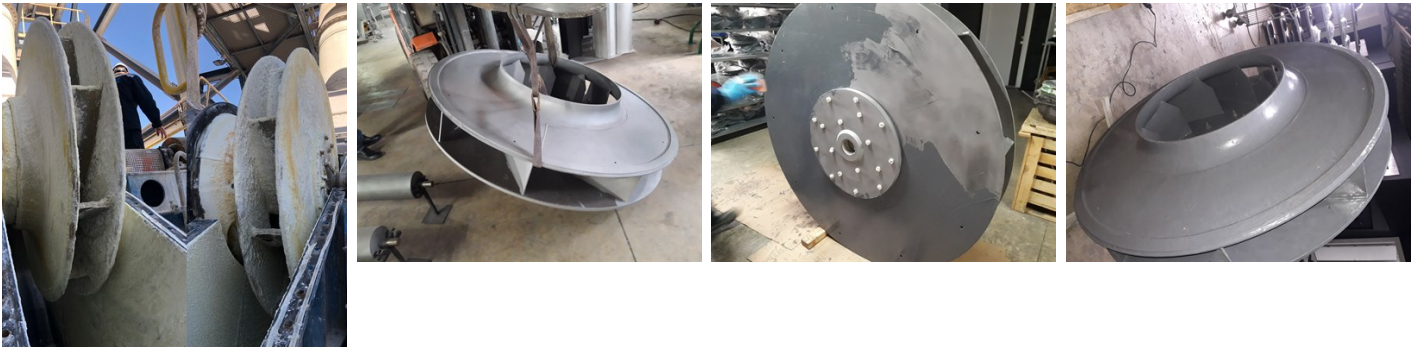
Photograph Descriptions

Particulates had corroded the previous scrubber fan surface. Items were building up on the steel and affected the balance.

- * 1- Corroded previous Fan ,
- * 2- Surface Preparation - After grit blasting ,
- * 3- During the application ,
- * 4- Completed application with Belzona 1321 ,

New Scrubber Fan being fabricated and in need of corrosion protection.

The application was carried out in accordance with Belzona Know-How Leaflet FBC-2.

Firstly, the customer thought that stainless steel faced fan production would be more expensive than carbon steel faced fan production. Due to this reason, they had a carbon steel faced fan manufactured and they coated with Belzona 1321.
