# BELZONA SCRUBBER FAN COATING

ID: 8476

Industry: *Mining & Quarrying*  
Application: *FBC-Fans, Blowers and Compressors*

Customer Location: *Mining Industry, Turkey*  
Application Date: *January, 2021*

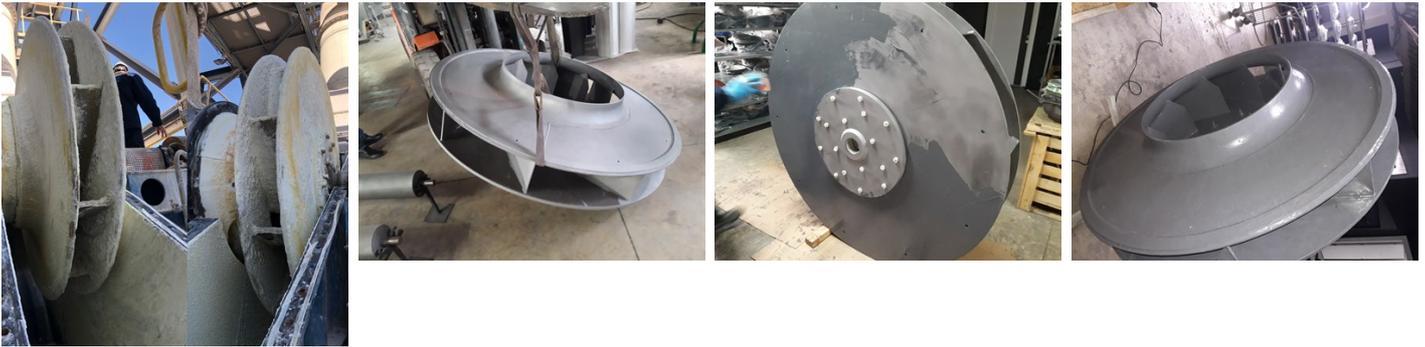
*Particulates had corroded the previous scrubber fan surface. Items were building up on the steel and affected the balance.*

- \* 1- Corroded previous Fan ,
- \* 2- Surface Preparation - After grit blasting ,
- \* 3- During the application ,
- \* 4- Completed application with Belzona 1321 ,

New Scrubber Fan being fabricated and in need of corrosion protection.

The application was carried out in accordance with Belzona Know-How Leaflet FBC-2.

Firstly, the customer thought that stainless steel faced fan production would be more expensive than carbon steel faced fan production. Due to this reason, they had a carbon steel faced fan manufactured and they coated with Belzona 1321.
