BELZONA SCRUBBER FAN COATING

ID: 8476

Industry: Mining & Quarrying
Application: FBC-Fans, Blowers and Compressors

Customer Location: Mining Industry, Turkey
Application Date: January, 2021

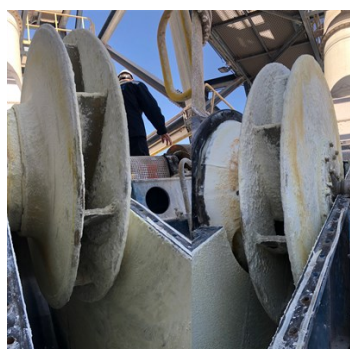
Particulates had corroded the previous scrubber fan surface. Items were building up on the steel and affected the balance.

- * 1- Corroded previous Fan ,
- * 2- Surface Preparation - After grit blasting ,
- * 3- During the application ,
- * 4- Completed application with Belzona 1321 ,
