# Belzona® Repairs Robotic Arm

ID: 8477

Industry: Food & Drink  
Application: VPF-Valves, Pipes and Fittings  
Substrate: Hard Aluminium  
Products: \* Belzona 1111 (SuperMetal) ,  
\* Belzona 9341 ,

Customer Location: Brewery, Romania  
Application Date: February, 2021

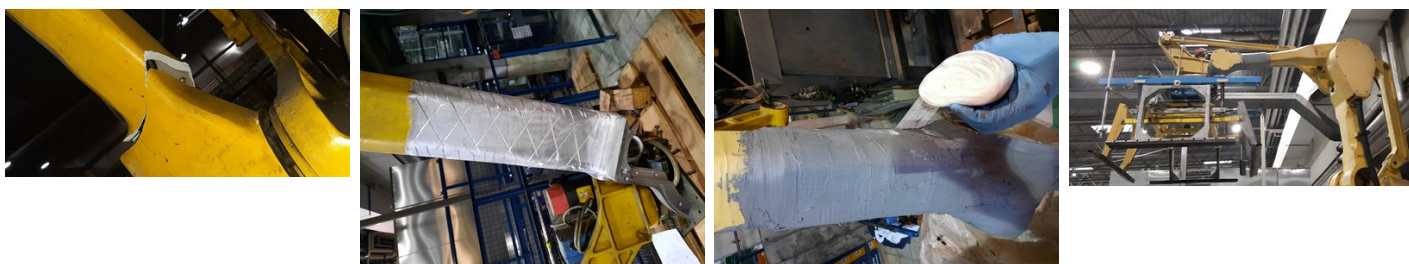
## Photograph Descriptions

The robotic arm, that lifts and moves around large plastic beer boxes, from stack to process lines, was totally broken due to the metal wear. It had been working continuously for the last 20 years.

- \* 1. The view of the broken robotic arm ,
- \* 2. The view of the surface prepared by using the MBX ,
- \* 3. The two pieces of the arm with the wrapping of the reinforcement sheet ,
- \* 4. The robotic arm with the completed repair .

After proper surface preparation, the application was carried out by putting the metal plates with screws on the broken arm. Belzona 1111 was applied between the two pieces of metal right on the tear of the pieces. After bonding the two pieces of the arm, the reinforcement sheet (Belzona 9341) was wrapped around the entire damaged area, which was wet out with Belzona 1111.

The use of Belzona products prevents the replacement of the full robot arm, which is very expensive and the downtime would have been around 7 weeks. Belzona provided fast return to operation of the robotic arm – 2 days. Inspection was carried out 3 weeks after putting the arm in operations. The robotic arm is in very good shape and works according to specification.
