Turbo Separator Repair With Belzona 1818

ID: 8480

Industry: *Pulp & Paper*
Application: *SHM-Solids Handling Machinery*

Turbo separator in Paper recycling plant

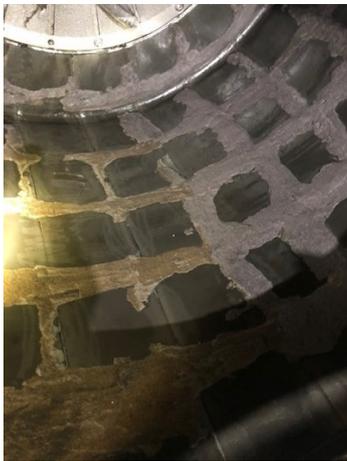
The Turbo Separator is a disc screen specially designed for coarse screening, primarily removing light and heavy impurities from wastepaper. The unit is lined with thick Basalt tiles and has a hard-wearing grouting compound applied over the joints between the tiles. Over the years, this grouting compound would wear away leaving the joints unprotected. This is a very abrasive environment.

Worn grouting system

After cleaning out the pulp, the Turbo separator was dried out using rags. Surface preparation was achieved using a diamond blade on an angle grinder to create a "key" for Belzona 1818.

Belzona 1818 was mixed and applied with ease, including overhead areas.

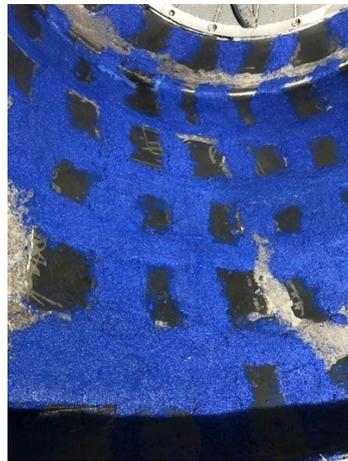
Application in progress

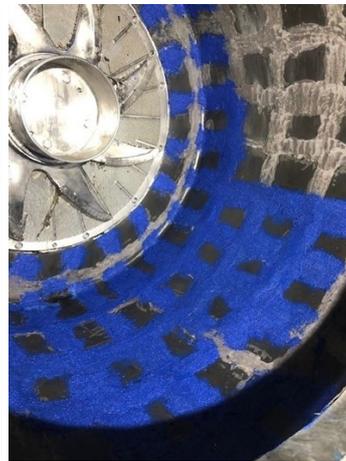
Application in progress

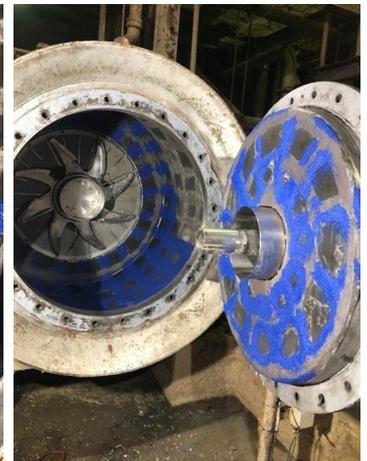
Application complete

Previously, Belzona 1812 was used to repair this turbo separator. Belzona 1818 provided: - Easier vertical and overhead application - Lower surface preparation needs - Quicker back to service - Time and cost savings.
