# Repairing and coating of the concrete Sulphur tank

ID: 8483

Industry: *Chemical & Petrochemical*  
Application: *TCC-Tanks and Chemical Containment Areas*

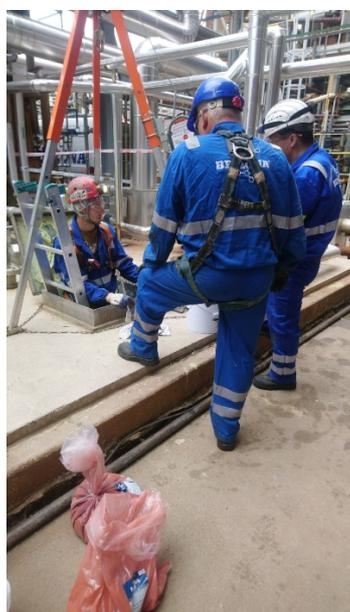
## Photograph Descriptions

*The concrete underground tank for liquid Sulphur was damaged. The longer wall of the tank crashed down. 100 % liquid Sulphur in this process can have a temperature up to 150°C and customer needed quick and quality repair.*

- \* 1. Customer needed to repair concrete underground tank ,
- \* 2. After the Belzona 4981 application ,
- \* 3. Belzona 4181 application ,
- \* 4. Sulphur concrete tank ready to use ,

The application was carried out in accordance with Belzona System Leaflets TCC-9 and TCC-15. Damaged and loose concrete was removed. Then we used the blasting process. We made sure the surface of the concrete is clean/dry/free of any loose contaminants and then we used to condition the surface with your 4981. The eroded vertical surface of the tank was rebuilt with Belzona 4181. In the end Belzona 1392 has been applied.
