Belzona 1212 for Emergency pump repair

ID: 8489

Industry: Water / Wastewater
Application: PDP-Positive Displacement Pumps

Wastewater lift station pump

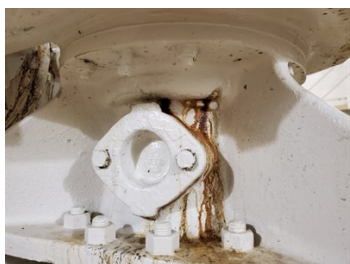
A faulty section of weld on the lower side of the pump was leaking raw sewage.

- * 1. Original condition of the pump. ,
- * 2. Paint removed and ready for the 1212. ,
- * 3. First application of 1212 with a small drop of water on the left side. ,
- * 4. Second application of 1212 and leak sealed. ,
