BELZONA COATED CHILLERS 10 YEARS ON

ID: 849

Customer Location: *Olympic Stadium: Montréal, Canada*
Application Date: *1996*

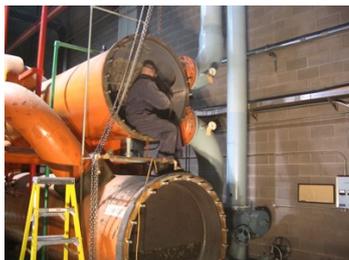
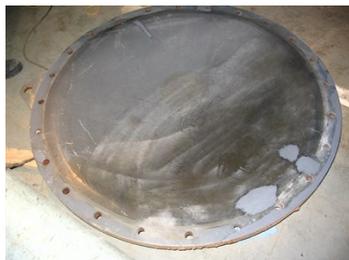
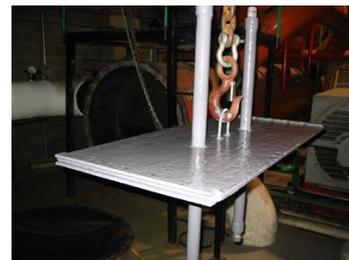
Photograph Descriptions

* The chiller units , * The covers required minor touch-up , * The separator bar after 10 years , * The separator good for another 10 years ,

Application was done according to Belzona System leaflet HEX-1. After 10 years, Separator was sandblasted and entirely re-coated. Small touch ups were needed on covers and separator slides. The gap on separator was opened up with sandblast to solve this problem and sliding was made easier.
