Backup Generator - Diesel Tank Restoration With Belzona

ID: 8498

Industry: Power

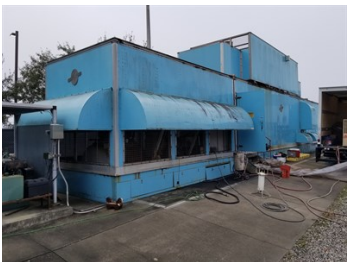
- * 1- Generator ,
- * 2- Section of Corrosion ,
- * 3- Belzona 4911 & 4131 being applied ,
- * 4- final coat of Belzona 5811 ,

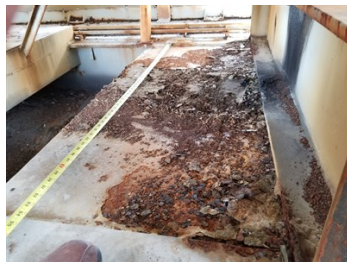
Water and rust were getting into the fuel system putting equipment at risk.

Severe corrosion on top of the tank leading to pinholes.

Clean Top of the Steel Tank. Needle Gun used to remove Heavy Scale from Years of Corrosion. Surface SpongeBlasted to a SSPC-SP10 Near White Condition. If the surface preparation perforated the metal, the repair was Cold Bonded with a plate repair using Belzona 1121. One Coat of Belzona 4911 Conditioner. Install Belzona 4131 to create a slope for the water to Evacuate from the middle on both sides of the tank. Top Coat with Belzona 5811
