# Hospital - Air Handler Fan Wheel Shaft Repair With Belzona

ID: 8499

Industry: *Buildings & Structures*  
Application: *FBC-Fans, Blowers and Compressors*

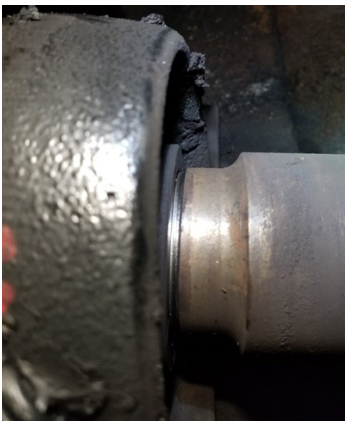
- \* Picture 1 - Shaft damage ,
- \* Picture 2 - Shaft surface prepared ,
- \* Picture 3 - 3D former in place ,
- \* Picture 4 - New bearing in place ,

Air handler pillow bearing ceased and galled a 1/8" groove into the air handler fan wheel shaft.
