# BELZONA RESTORES TWO PUMP IMPELLERS

**Industry:** General Industry  
**Application:** CEP-Centrifugal Pumps  
**Substrate:** Bronze  
**Products:** \* Belzona® 1111 (Super Metal) ,  
\* Belzona® 1321 (Ceramic S-Metal) ,

**Customer Location:** Oyster culture, The Netherlands  
**Application Date:** April 2007

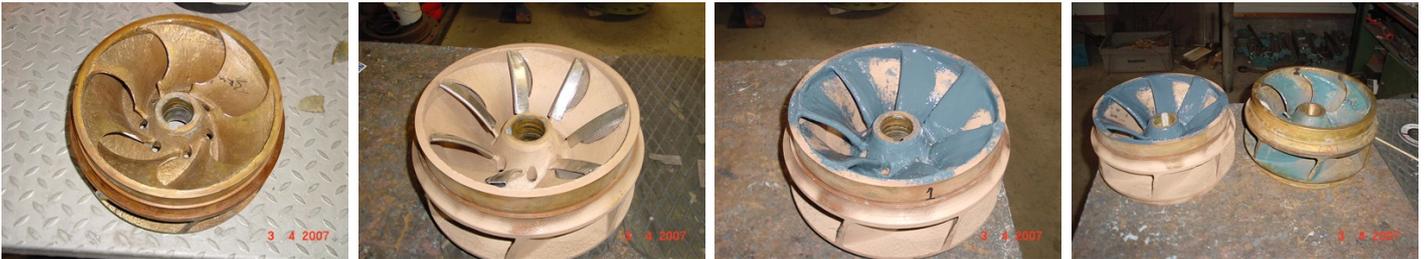
## Photograph Descriptions

The two impellers had severe damage because a large bolt was left in the inlet of the pump

- \* Damaged impeller ,
- \* Stainless steel infill plates ,
- \* Belzona® 1111 used to bond plates and restore profiles ,
- \* One repaired alongside one still to be repaired ,

Application was carried out in accordance with Belzona Know-How System Leaflets CEP-1 & 3. Steel plates were formed to recreate the lost vanes. Wire mesh was also incorporated into the Belzona rebuild as the original profile was restored. Repair was coated with Belzona® 1321 to give additional smoothness and erosion protection.
