Belzona Repairs 4km Long Conveyor Belt

ID: 8502

Repair of a 4km long conveyor belt at a copper mine.

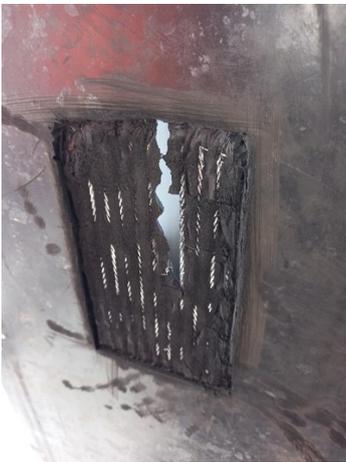
The track braking system of the conveyor belt failed causing copper ore to build up the belt. The hopper then became blocked and material began to flow out of the conveyor belt. Large pieces of ore jammed in-between the belt and driver roller causing the belt to rip in several places.

- * 1.) Before application ,
- * 2.) Surface preparation ,
- * 3.) Final application ,
- * 4.) Conveyor belt back in operation ,
