# Belzona Repairs 4km Long Conveyor Belt

ID: 8502

Repair of a 4km long conveyor belt at a copper mine.

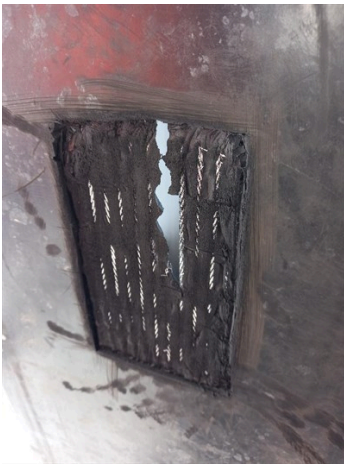
The track braking system of the conveyor belt failed causing copper ore to build up the belt. The hopper then became blocked and material began to flow out of the conveyor belt. Large pieces of ore jammed in-between the belt and driver roller causing the belt to rip in several places.

- \* 1.) Before application ,
- \* 2.) Surface preparation ,
- \* 3.) Final application ,
- \* 4.) Conveyor belt back in operation ,
