Belzona Repairs 4km Long Conveyor Belt

Repair of a 4km long conveyor belt at a copper mine.

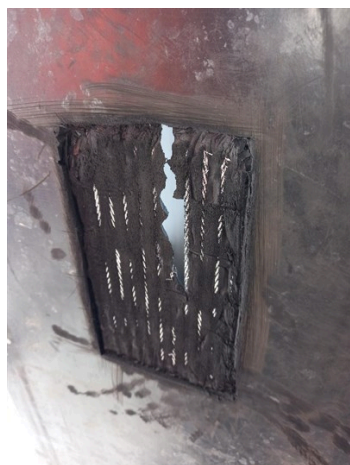
The track braking system of the conveyor belt failed causing copper ore to build up the belt. The hopper then became blocked and material began to flow out of the conveyor belt. Large pieces of ore jammed in-between the belt and driver roller causing the belt to rip in several places.

- * 1.) Before application ,
- * 2.) Surface preparation ,
- * 3.) Final application ,
- * 4.) Conveyor belt back in operation ,
