Generator-side cover wear tackled with Belzona

ID: 8517

Customer Location: Austria
Application Date: April 2020

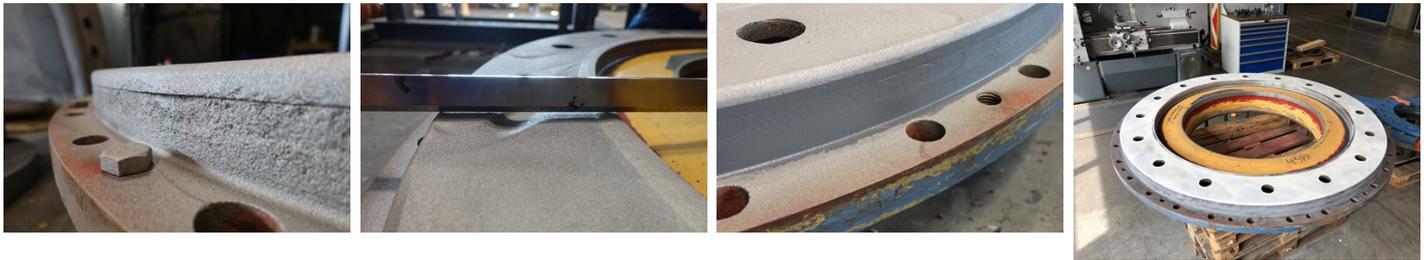
Photograph Descriptions

The flat surface of the cover, where the turbine guide vanes are mounted, was very heavily worn. Additionally, the outer diameter of the cover had worn, becoming very uneven and losing up to 5cm of thickness.

- * 1. Damaged edge after blasting ,
- * 2. Damaged cover face after blasting ,
- * 3. Edge repaired with Belzona 1331 ,
- * 4. Application completed and machined to fit ,

The application was carried out in accordance with a modified version of Belzona Know-How System Leaflet VPF-1. The surface was prepared by grit blasting to a near white metal finish and a surface profile of 90 microns. The outer diameter of the cover was rebuilt using Belzona 1311 to create an even and concentric finish. The face of the cover was then coated with Belzona 1331 up to a thickness of 3mm. Finally, both the Belzona 1311 and Belzona 1331 were inspected, touch ups were applied to remove small air pockets, and the surface was machined to the required dimensions and finish.

Typical repairs to this equipment include filling localised damaged areas. However, in this instance, due to the extent of the metal loss, filling alone would not have been sufficient to level the entire surface, therefore the entire surface needed to be covered and machined back to tolerance. Using hot work methods such as welding over such a large area would have been excessively time

consuming, and would have added heat stresses into large areas of the cover. For those reasons, it was decided to use Belzona materials, as they easily applied over larger areas with less labour, and do not induce heat stresses into the substrate. The application was carried out over a 4 day period, allowing for curing times, and comfortably back in service by the target date.
